**Flood Control Project Maintenance
Levee Inspections**

Fall 2011 Levee Maintenance Deficiency Summary Report

Sacramento River Basin

Reclamation District No. 0900 West Sacramento

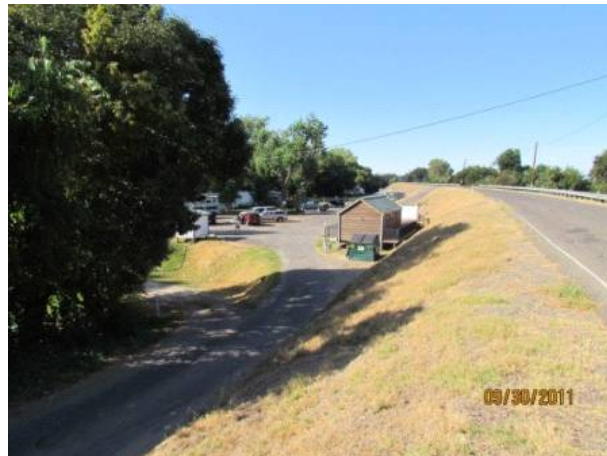
View of Sherwood harbor's unpermitted properties on the waterside of the levee. The picture was taken from the crown looking upstream.

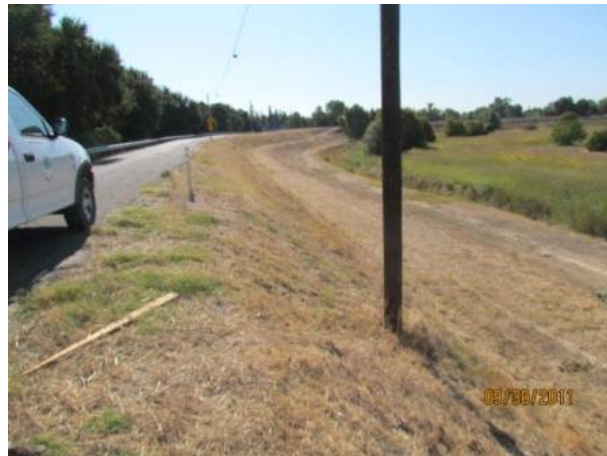
View of the pole on the landside of the levee looking upstream.

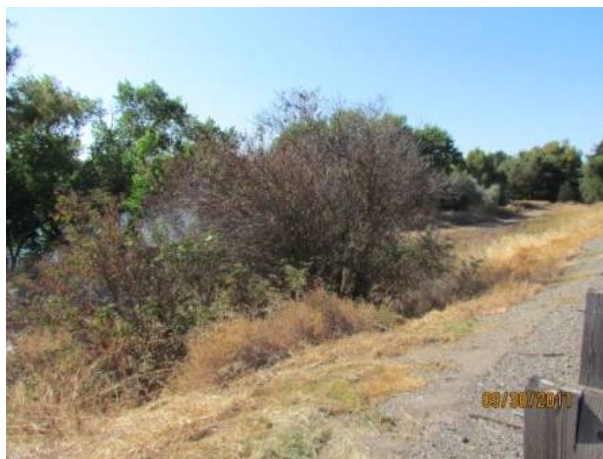
View of Elderberry tree on the waterside of the levee looking upstream.

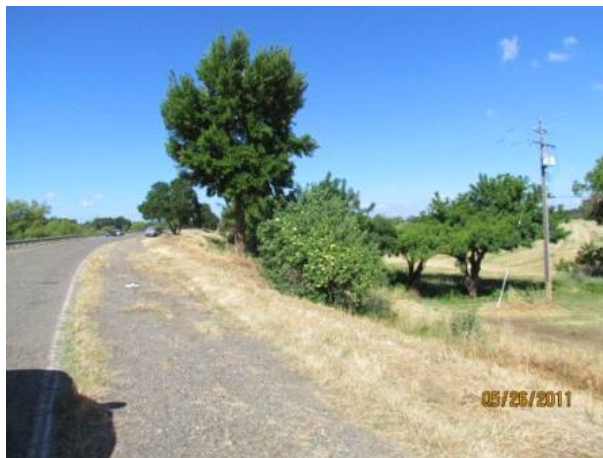
Levee Mile Report Line	55
Start Levee Mile	5.53
End Levee Mile	5.53
Location	Land Side
Category	Earthen Levee
Item	Vegetation

Elderberry on the landside of the levee. The picture was taken from the crown looking downstream.

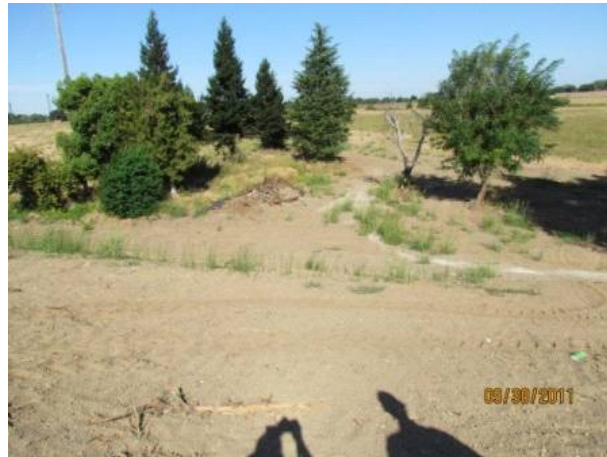
An old encroachment was removed from this area but little debris still remains on the landside of the levee looking upstream.

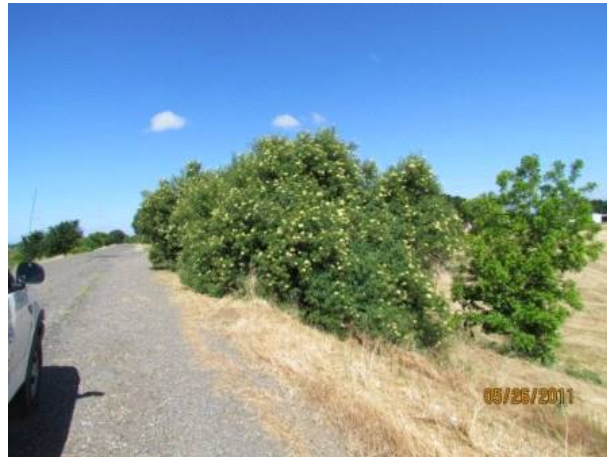
Elderberry located on the landside of the levee obstructing the view. The picture was taken from the crown looking downstream.

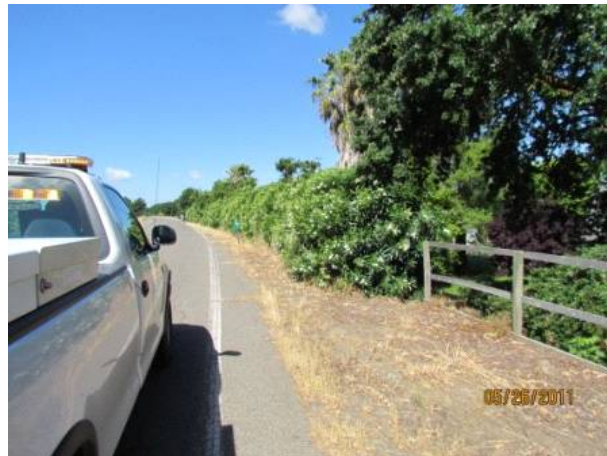
Levee Mile Report Line	65
Start Levee Mile	6.57
End Levee Mile	6.63
Location	Land Side
Category	Earthen Levee
Item	Encroachments

Landscaping was obstructing the view on the landside of the levee. The picture was taken from the crown looking downstream.

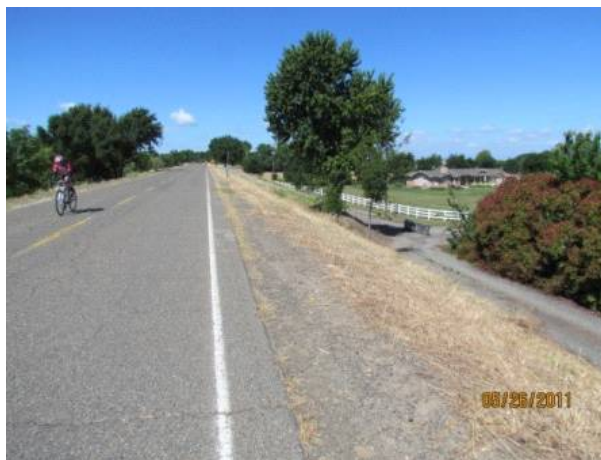
Vegetation and trees complied with standards on the landside of the levee. The picture was taken from the crown looking downstream.

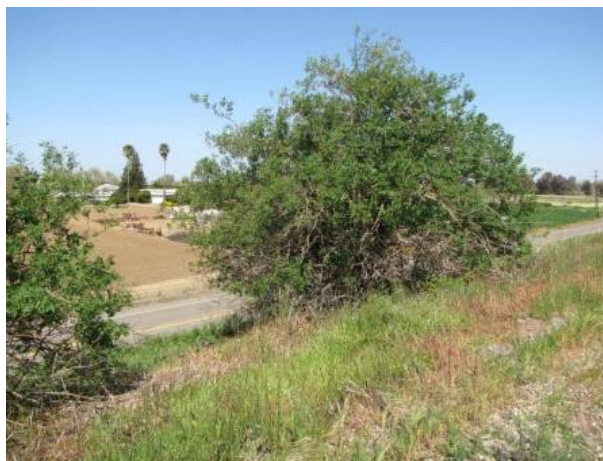
View of elderberries blocking visibility on the landward slope looking upstream.

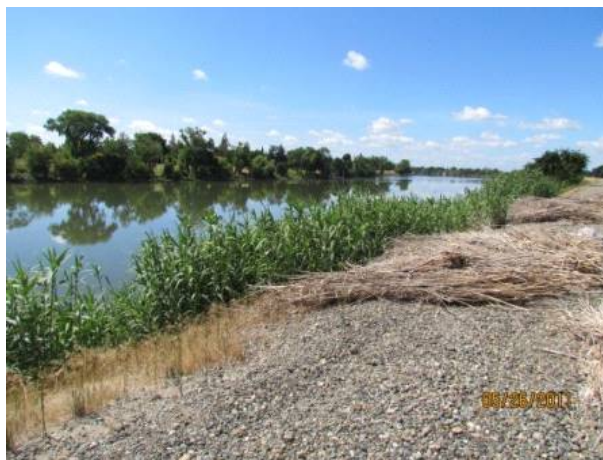
Arundo on the waterside slope of the levee. The picture was taken from the crown looking downstream.

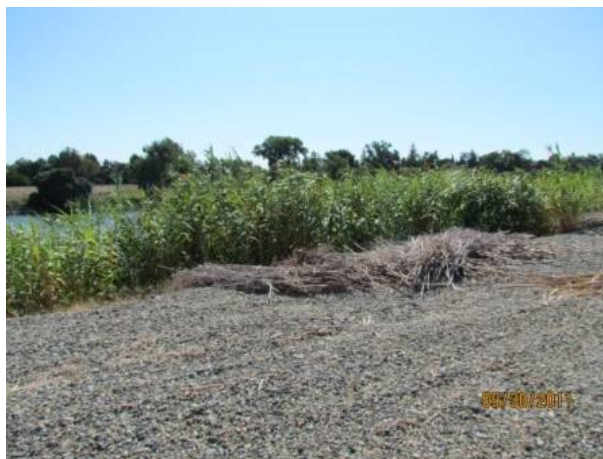
Levee Mile Report Line	73
Start Levee Mile	7.50
End Levee Mile	7.50
Location	Water Side
Category	Earthen Levee
Item	Vegetation

View of arundo on the waterside of the levee looking upstream during fall 2011 inspection.

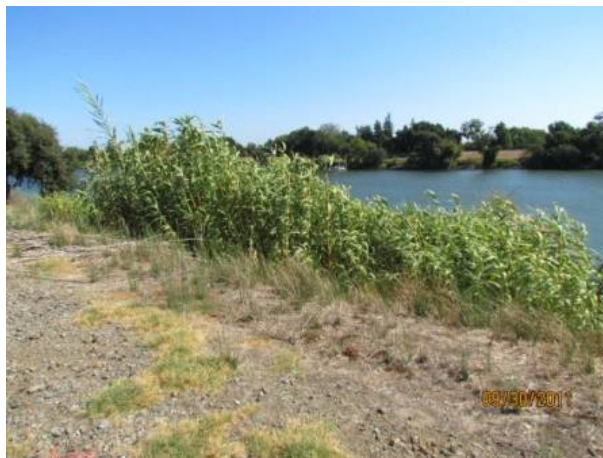
Levee Mile Report Line	74
Start Levee Mile	7.81
End Levee Mile	7.81
Location	Water Side
Category	Earthen Levee
Item	Vegetation

View of arundo on the waterside of the levee. The picture was taken from the crown looking downstream.

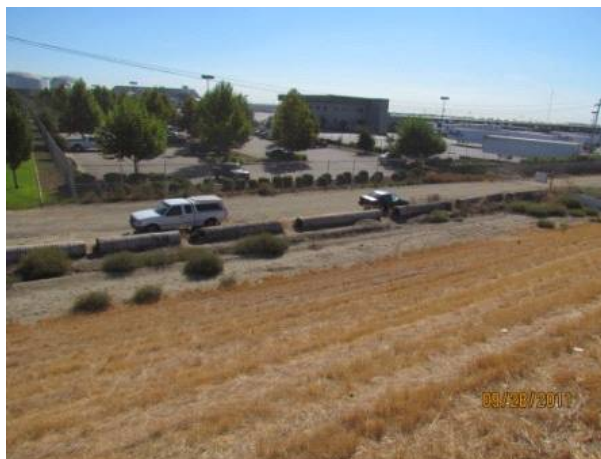
Pipes were placed at the toe of the landside of the levee to prevent people from driving on the slope. The picture was taken from the crown looking upstream.

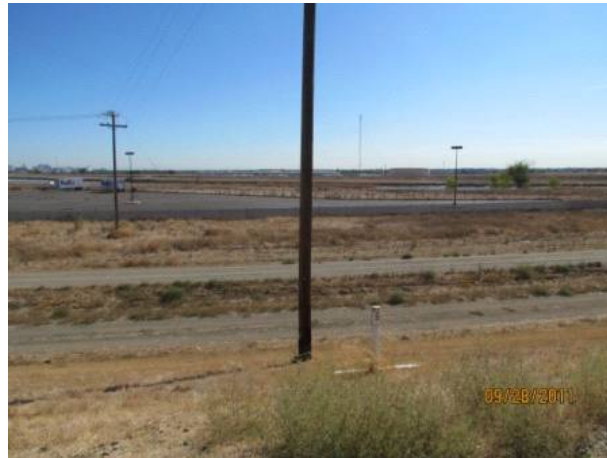
Wood pole for electrical lines was located on the landside of the levee. The picture was taken from the crown looking upstream.

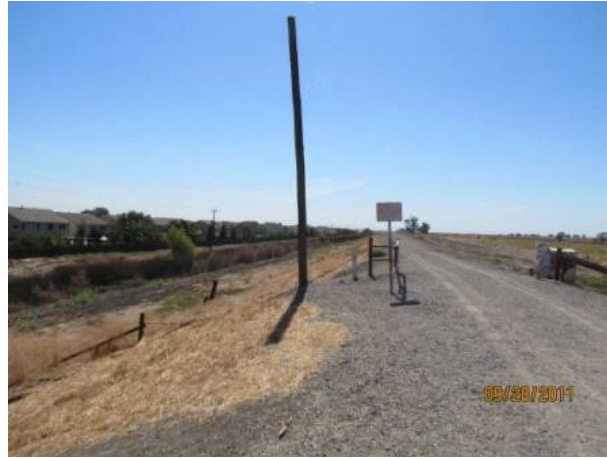
A pole was located on the landside of the levee which will be removed by spring 2012. The picture was taken from the crown looking upstream.

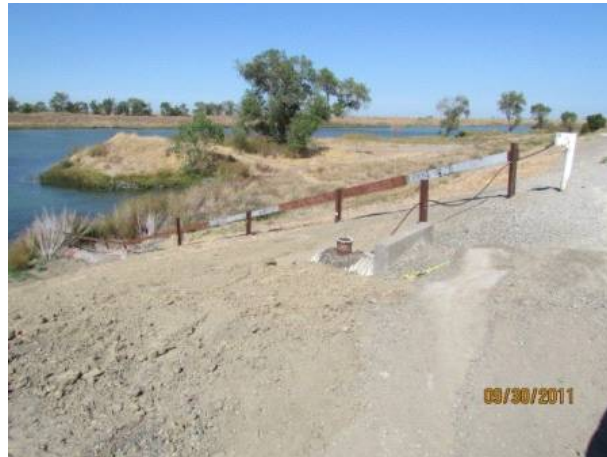
Levee Mile Report Line	12
Start Levee Mile	3.26
End Levee Mile	3.26
Location	Water Side
Category	Earthen Levee
Item	Encroachments

Abandon pump station structure was removed during fall 2011 inspection but existing pipe still remains on the waterside slope of the levee. The picture was taken from the crown looking downstream.

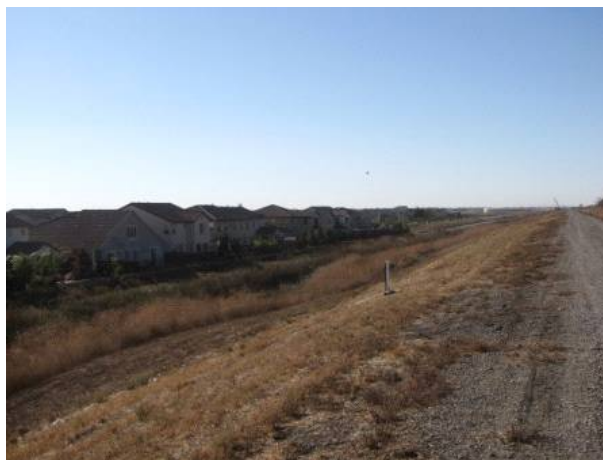
View of vegetation along the toe adjacent to the ditch looking downstream.

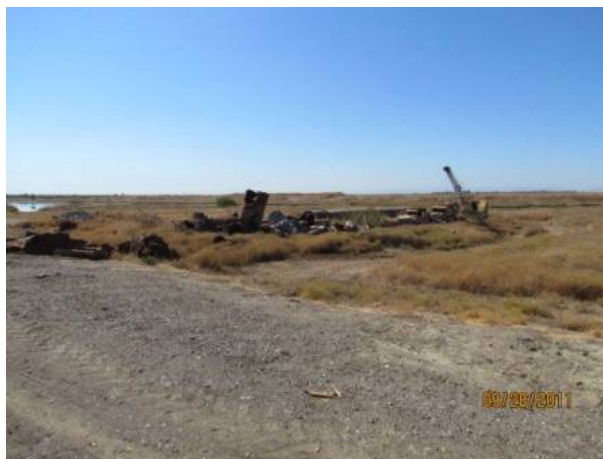
Levee Mile Report Line	22
Start Levee Mile	4.85
End Levee Mile	4.85
Location	Water Side
Category	Earthen Levee
Item	Encroachments

Metal equipments and debris are purposely placed next to the gate by the LMA for barricade. The picture was taken from the crown looking upstream.

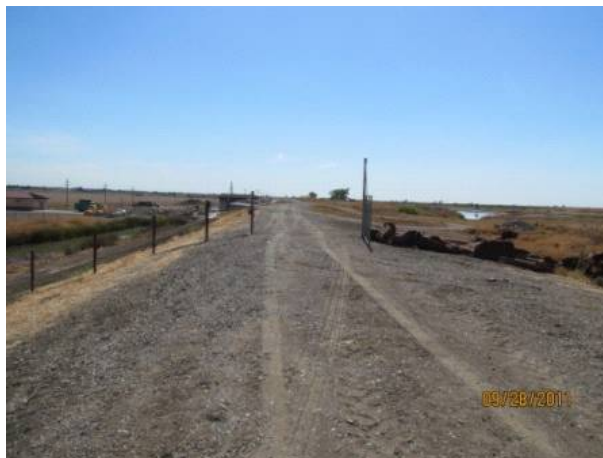
Levee Mile Report Line	23
Start Levee Mile	4.85
End Levee Mile	4.85
Location	Crown
Category	Earthen Levee
Item	Encroachments

23	4.85	4.85	Earthen Levee	Encroachments	CR	PO	Buildings Inspector Comments: A gate was put in by the LMA to keep the vehicle out.	38.518072 ° -121.582129 °	38.518072 ° -121.582129 °	392 Y	
24	4.92	4.98	Earthen Levee	Encroachments	LS	PO	Fences	38.517026 ° -121.582224 °	38.516157 ° -121.582222 °	2	
25	4.96	4.96	Earthen Levee	Encroachments	LS	PO	Buildings Inspector Comments: Ongoing pump station replacement project underway, permit #18116.	38.516465 ° -121.582225 °	38.516465 ° -121.582225 °	12 Y	
26	5.02	5.02	Earthen Levee	Encroachments	LS	PO	Poles Inspector Comments: 2 power poles in the levee toe supplying power to the district pumping plant.	38.515519 ° -121.582185 °	38.515519 ° -121.582185 °	20	
27	5.06	5.06	Earthen Levee	Encroachments	WS	M	Debris	38.514976 ° -121.582204 °	38.514976 ° -121.582204 °	393 Y	
28	5.07	5.07	Earthen Levee	Encroachments	LS	PO	Poles Inspector Comments: Power pole in the levee toe supplying power to the district pumping plant.	38.514929 ° -121.582163 °	38.514929 ° -121.582163 °	21

A gate is installed by the LMA on the crown of the levee looking upstream.

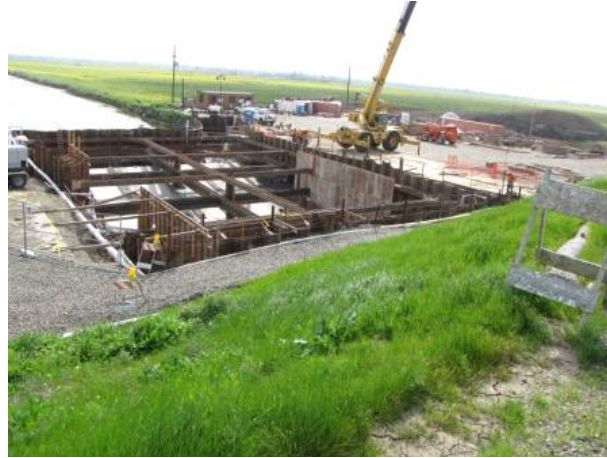
View of the open pit and construction activity on a new pump station on the landward side of the levee.

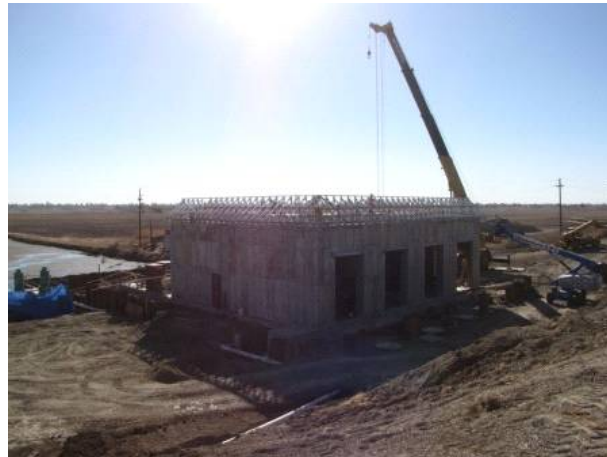
Levee Mile Report Line	25
Start Levee Mile	4.96
End Levee Mile	4.96
Location	Land Side
Category	Earthen Levee
Item	Encroachments

View of construction as of fall 2010.
